**REVIEW OF  
LIGHTNING PROTECTION TECHNOLOGY  
FOR  
TALL STRUCTURES**

**Sponsored By:**

**Office of Naval Research  
National Aeronautics and Space Administration  
Federal Aviation Administration  
U.S. Air Force**

**Held at the  
Lyndon B. Johnson Space Flight Center  
Houston, Texas**

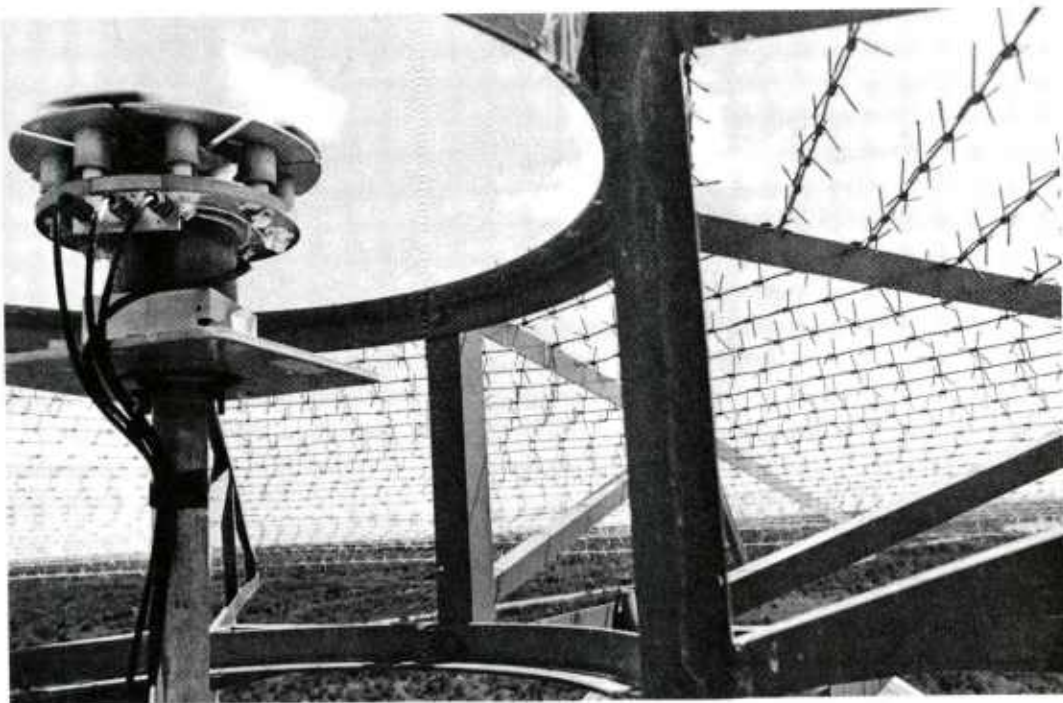
Figure 4. Close up of umbrella array at MILA

The dissipating wire is the material used to form the umbrella array, the truncated cone and the barrier types of arrays, whereas the rigid conducting material forms a disc or panel array. Figure 3 shows an umbrella array installed on a 100 foot collimation tower at NASA/GSFC's satellite tracking station on Merritt Island, Florida. The array is approximately 20 feet in diameter and is comprised of the dissipating wire wrapped spirally around the "umbrella" framework. A close-up of the array is shown in Figure 4. Approximately 1000 feet of the dissipating wire is used in such an array.

A closer view of the collimation tower complete with umbrella array is shown in Figure 13<sub>a</sub>, a close up of the array in Figure 4. The building at the base of the tower housed an 8 channel Brush Recorder (Fig. 13<sub>b</sub>). Also visible in Figures 13<sub>a</sub> and <sub>c</sub> are 3 tripods which were used for corona current and field mill investigations. These tripods were each 20 feet tall and were separated by a distance large enough that they would not normally electrostatically interfere with one another. Field mills were located atop the 5 ft and 20 ft tripods, and the other two tripods were used for corona current investigations.

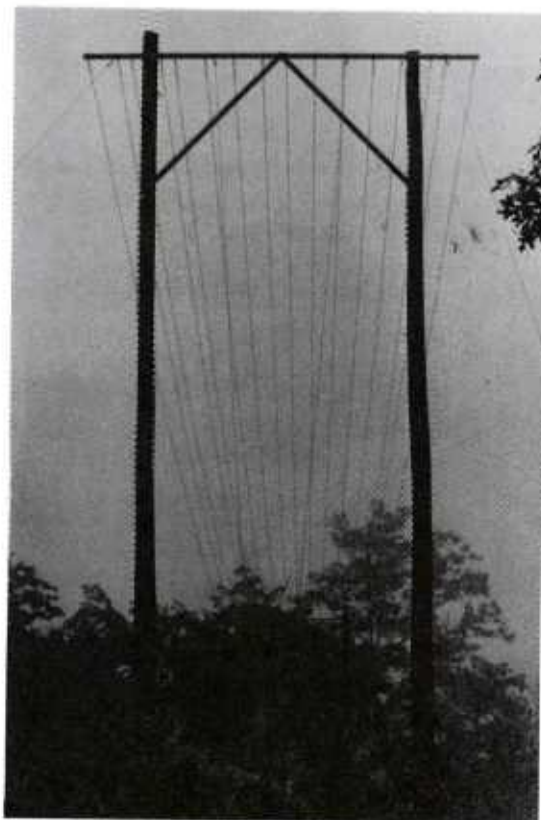
Figure 5.  
Barrier array at  
Rosman, N.C.

Figure 6.  
Guy rope dissipation  
wire added to an array  
at Rosman, N.C.

A barrier array is shown in Figure 5. Such an array can house any length of the dissipating wire and the one illustrated is installed at the NASA/GSFC Rosman satellite tracking facility. The height of the array is 40 ft and it has seventeen strands of wire each separated by over 1 ft running for a length of 170 ft, giving a total wire length approaching 3000 ft.

The truncated cone array is attached to a tower and is made up of a number of dissipating wires formed around the tower in guy rope fashion. This type of array, however, puts a considerable portion of the dissipating wire in a region of reduced electric field thereby lowering the amount of corona current and increasing the field required for initial corona breakdown. Such an array is shown in Figure 6 underneath an umbrella array located at the NASA/GSFC Rosman facility. At times the dissipating wire is passed around the roof perimeter of a building, as is shown in Figure 7. This array is also at the NASA/GSFC Rosman facility.

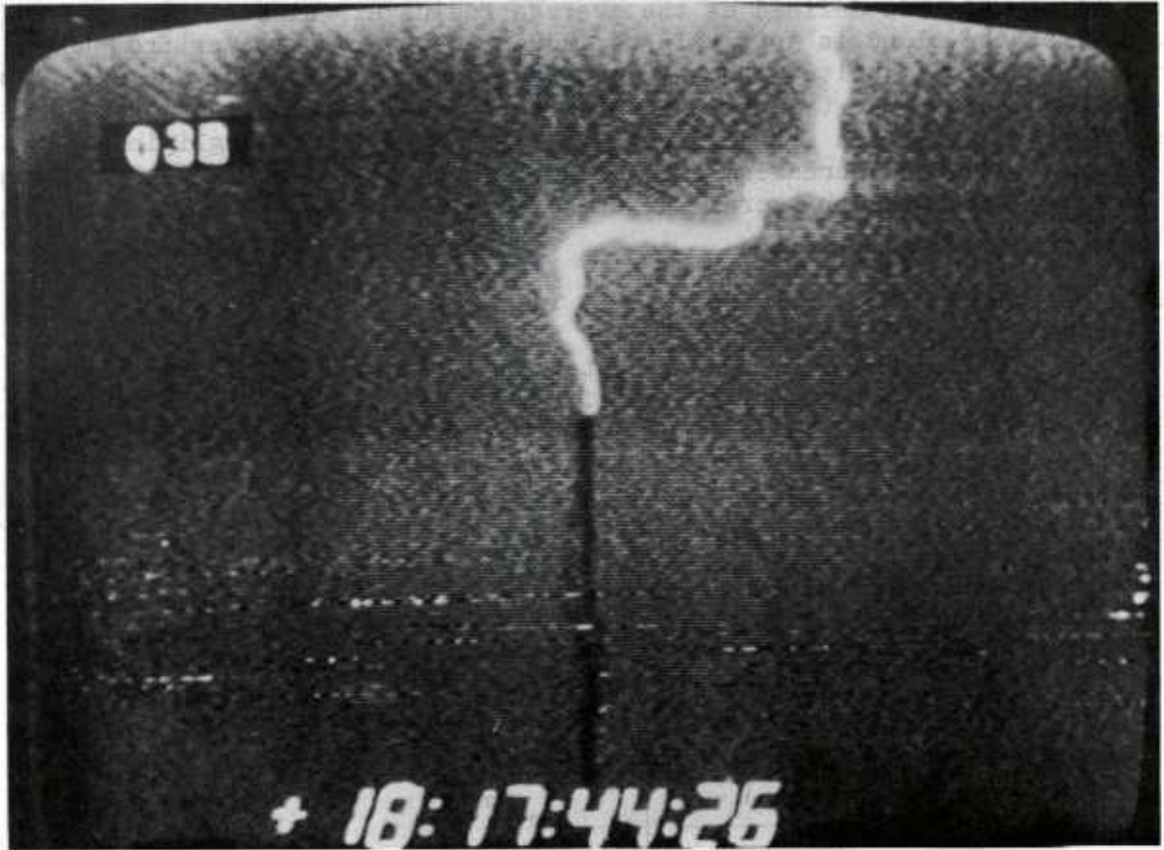
Figure 11.

Lightning striking a 500 foot meteorological tower at  
NASA's Kennedy Space Center, Florida, and hitting  
the dissipation array

An excellent photograph of the striking distance phenomena just described is shown in Figure 11 where lightning is striking a 500 foot tower at NASA/KSC. This photograph was supplied by NASA/JSC, Houston. At the time of the strike a dissipation array was on top of this tower, but according to the manufacturer the galvanizing process had not been performed properly and the array was not working; it was replaced shortly afterwards. Once more, however, we would like to reiterate that we believe the metallic finish of a grounded conductor should not influence the formation of ions above it in the avalanche process.

NASA/KSC personnel also measured the corona current from a panel type dissipation array on top of a 500 foot tower at KSC and found that the value throughout the summer thunderstorm season remained below 200  $\mu$ A. This array was also struck by lightning (Figure 11).

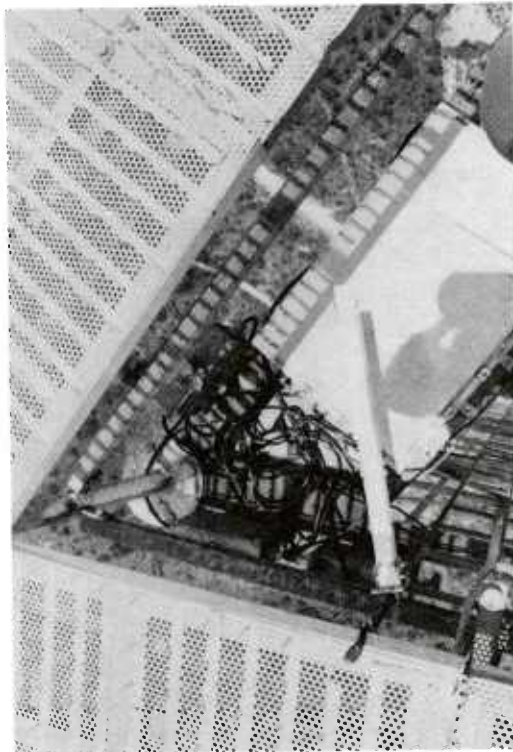
Figure 20 c. View down the middle of the 1200 ft  
tower showing the magnetic link arm

Figure 20a is a photograph of the 1200 foot tower; Figure 20b shows a view of the panel arrays. Close examination shows the dissipation wire at the edge of the array. Figure 20c is a downward view of the panel array showing the sharp 4 cm spikes.

The positioning of the two arms was not ideal, for monitoring current from the lightning strike as it was unlikely that the number 6 copper wire from the array would be carrying all the current if the array had been struck. In fact, most of the current would probably pass down the tower structure. The magnetic link data would, however, act as an indicator that lightning had struck and give some idea of the order of magnitude of the current. In later tests when a single lightning rod was put up, it would give accurate measurements of peak current. A magnetic link arm is shown in photograph 20c.

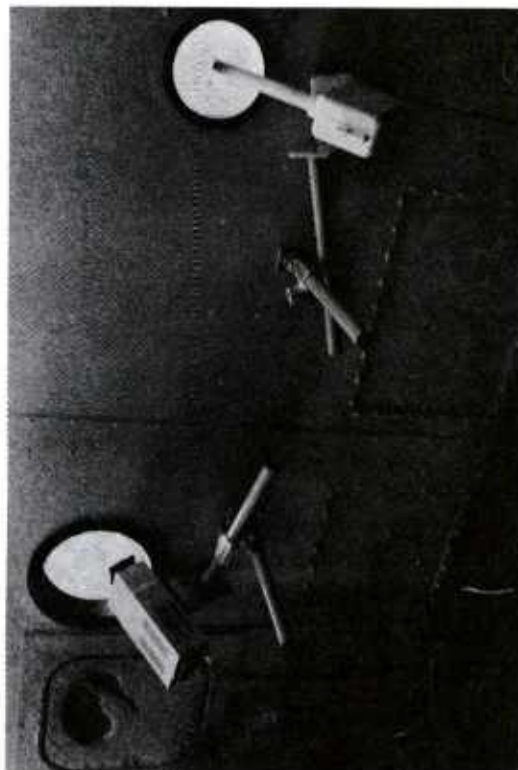
Figure 21 a.

Silicon diode video camera and lightning transient detector in the trailer at site C9, Eglin A. F. B. looking at the 1200 ft tower

The silicon diode camera in the trailer was focussed on the tower through a wide angle lens with remote controlled iris that looked at the tower through a porthole in the trailer as shown at the left hand side of Figure 21a. The recording equipment is shown in Figure 21b and the position of the trailer as viewed from the tower is shown in Figure 21c. Figure 22a shows the 100 foot Rockhill forestry tower and Figure 22b shows the video equipment in position. A telephoto lens was used in this camera to focus the image on the 1200 foot tower.

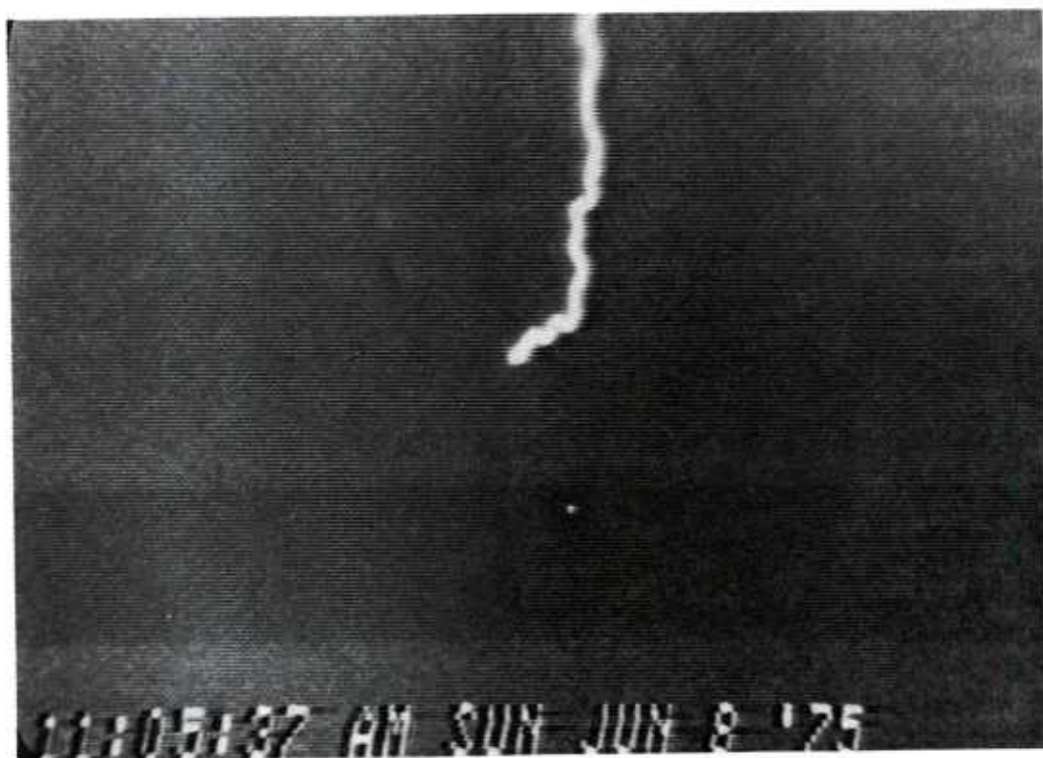
Figure 27 a.

Lightning striking an array on top of the 1200 ft tower  
as viewed from the forestry tower

The photographs shown in Figures 27a and b show two strikes to the tower as observed from the forestry tower on 1 May and 8 June 1975. The bright dot in the center of the picture is a fault on the silicon diode tube. Heavy rain was falling at these times, but later in the record the strike point was identified as the tower top. Further photographs of lightning to the 1200 foot tower array taken from the trailer are shown in Figures 28a-c. These occurred in May 1975 within a few seconds of one another and there is no doubt that the strike was to the array at the top of the tower. Two minutes later the tape recorder was damaged by a large surge in the remote control line, which ran from the base of the tower, probably indicating another strike. Figure 28c shows much blooming but indicates an upward going leader as a horizontal branch to the west is shown, whereas two frames later when the camera blooming stops it is evident that the main strike is vertical.

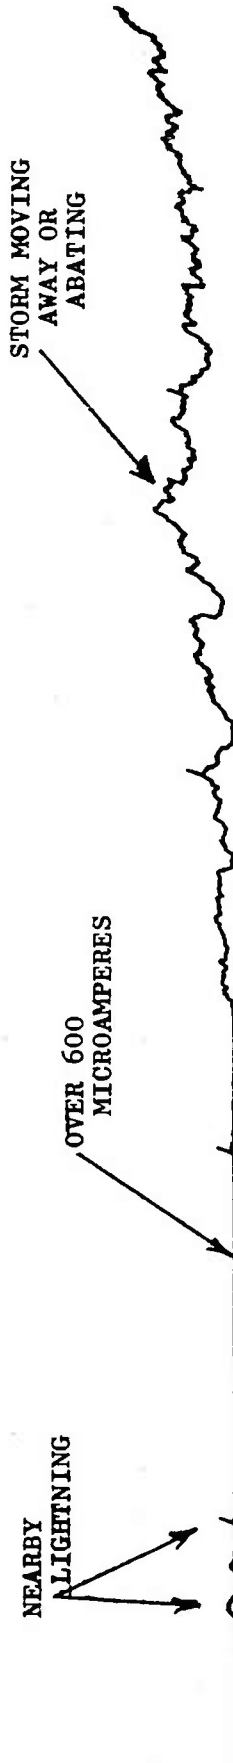
FIGURE 35 . OVERHEAD STORM, PANEL ARRAY CURRENT, MAY 20, 1974  
(from reference 20)

The Rosman data is very puzzling, especially in view of the Station Director's comments shown in Appendix 2, Section C. These comments state that the corona current data is severely degraded by other currents induced in the line as was noted when certain switches were thrown in unrelated lines. Figure 35 shows the recorded corona current (reference (20)) from a panel array at Rosman (this very same figure is also listed as Fig. 8 in the report by Roy Carpenter at the beginning of these proceedings where it is there listed as being from Eglin AFB on May 10, 1974) under a local storm saturating at a very large value of 600  $\mu$ A. As the storm moves away the corona current increases for a surprisingly long period of time and lightning is reported to occur at precisely 45 minute intervals which is obviously interference from a time source.

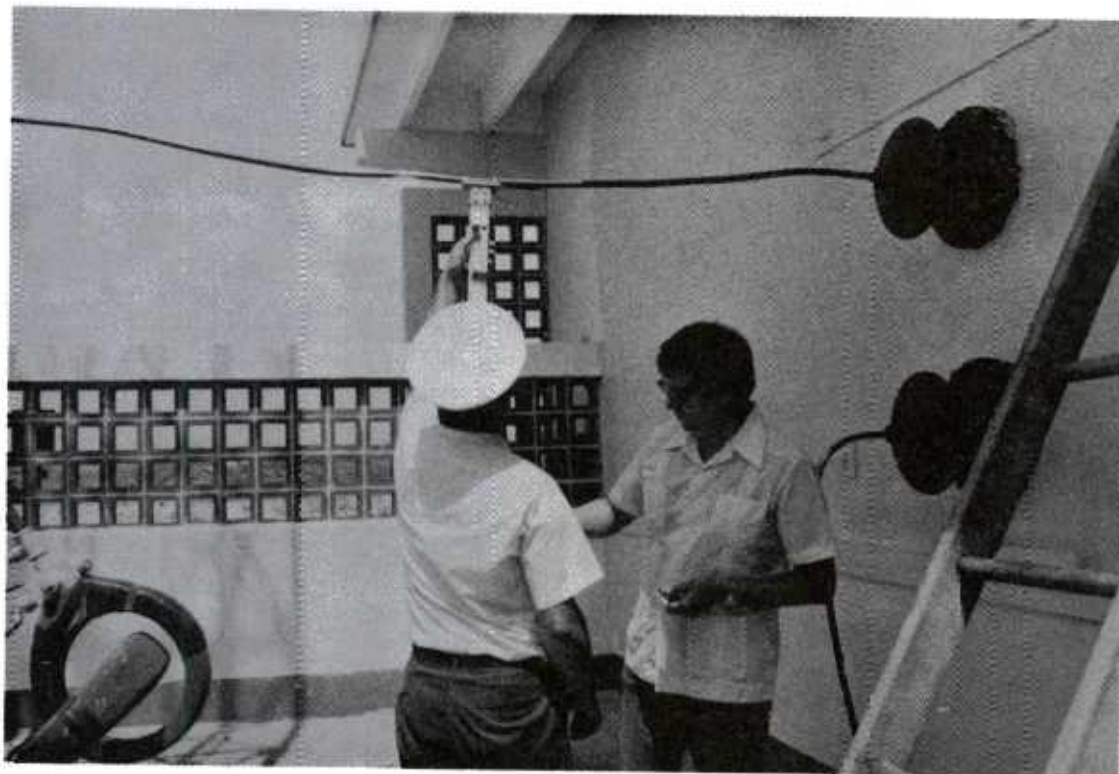
Figure 39 b. Magnetic links being fitted to the transmitter feed cable at the base of the 625 foot Loran C antenna

Magnetic links were placed on the transmitter wire between tower and building in order to measure lightning currents passing to the transformer. Figure 39b shows these links being put in place and also shows the spark gaps across one of the air-cored isolation transformers.

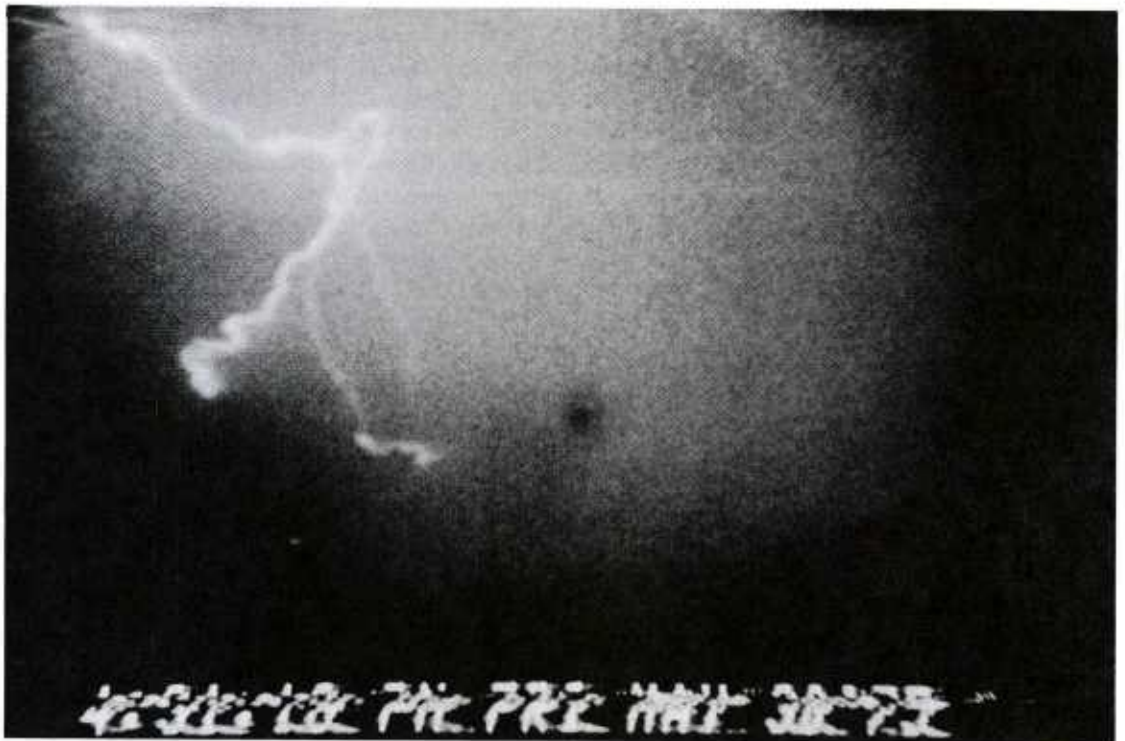
Figure 40 b. Intra-cloud lightning above the Loran C antenna at Jupiter, Florida
